# A.H.E.R.A.

## Management Plan for Asbestos Containing Building Materials

Willamette Primary  
1403 S.E. 12th Street  
West Linn, OR 97068

TRE Project No. 1020-90

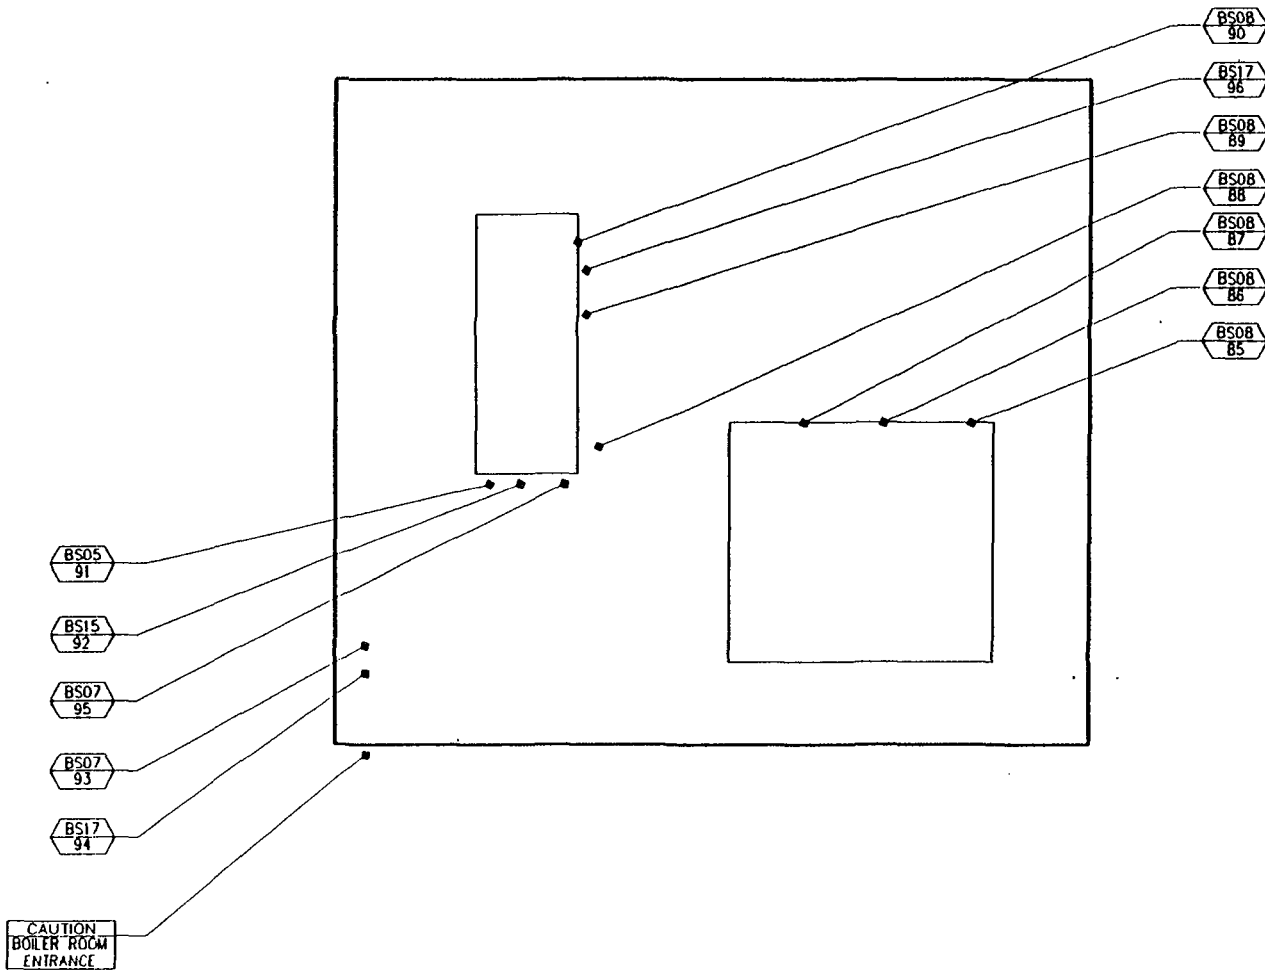
BSCODE QUANTITY LOCATION DAMAGE AREA	RESPONSE CODE	<b>HALL-KIMBELL ENVIRONMENTAL SERVICES</b> 4840 WEST FIFTEENTH STREET LAWRENCE, KANSAS 66044 DATE 10/04/88      006001A	<b>AHERA COMPLIANCE PROGRAM</b> 37-0050-006-001 WEST LINN SCHOOL DISTRICT WILLAMETTE SCHOOL BOILER ROOM

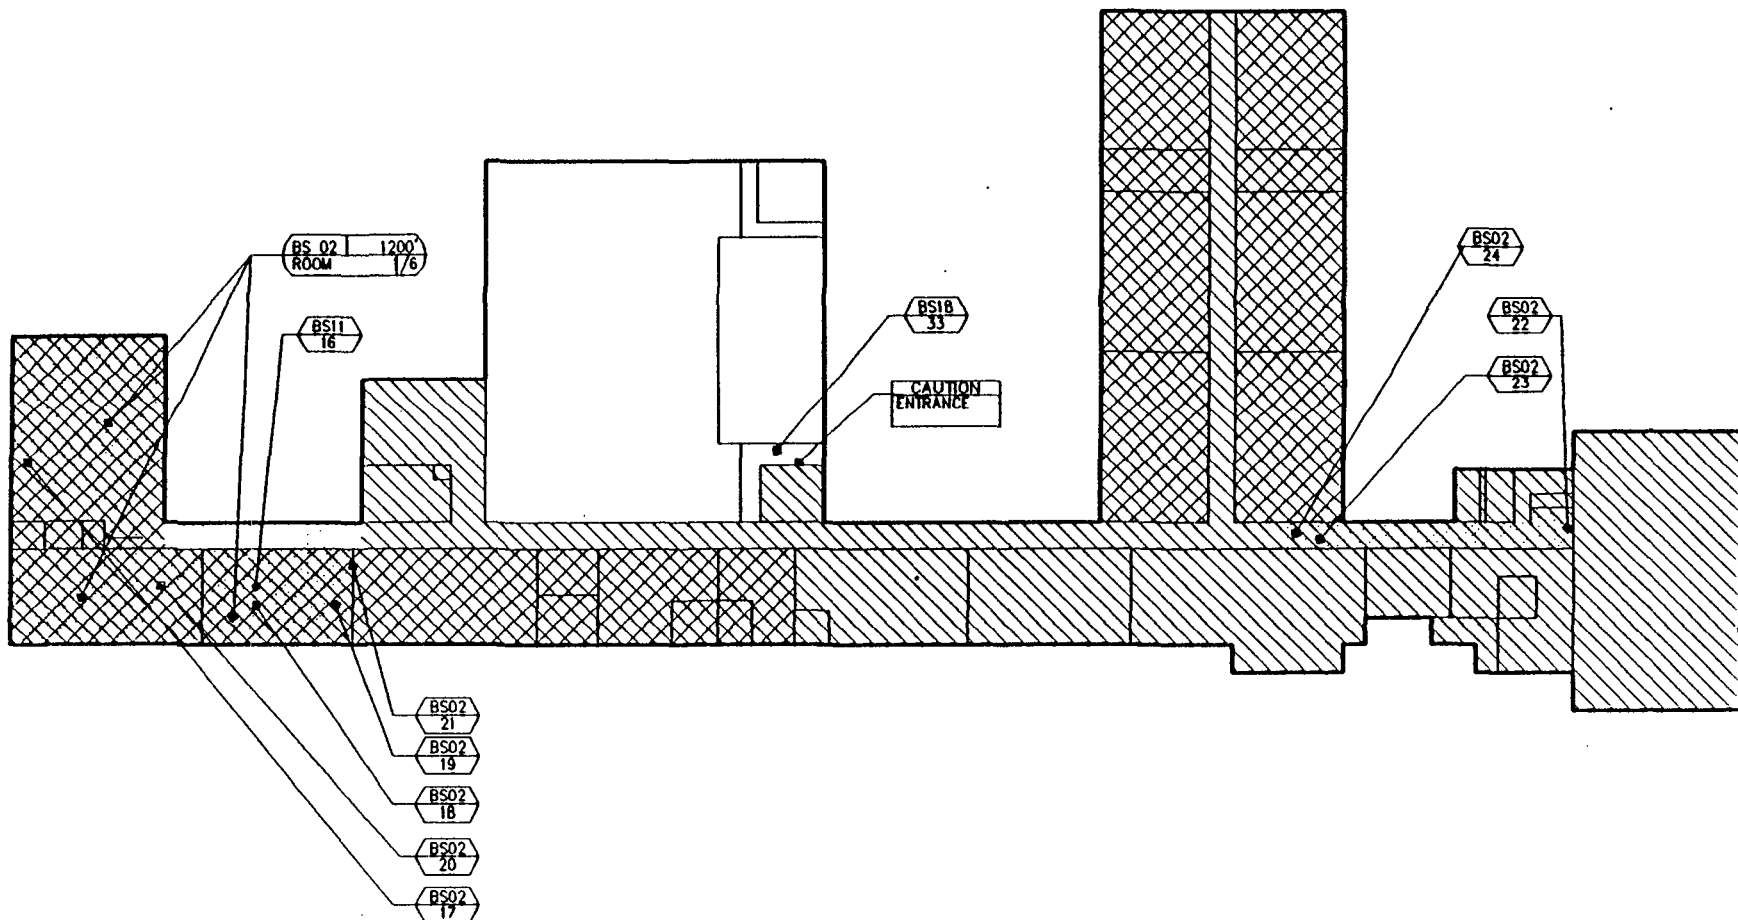
BSCODE QUANTITY LOCATION DAMAGE AREA	<b>HALL-THORPEL</b> ENVIRONMENTAL SERVICES 4840 WEST FIFTEENTH STREET LAWRENCE, KANSAS 66044 DATE 10/04/88      006001C	<b>AHERA COMPLIANCE PROGRAM</b> 37-0050-006-001 WEST LINN SCHOOL DISTRICT WILLAMETTE SCHOOL MAIN FLOOR PLAN
	RESPONSE CODE
