SYNTHETIC TURF FOOTBALL/SOCCER FIELDS EVALUATION REPORT

West Linn High School & Wilsonville High School

Submitted to West Linn - Wilsonville School District
by Dull Olson Weekes - IBI Group Architects, Inc.

March 19, 2013

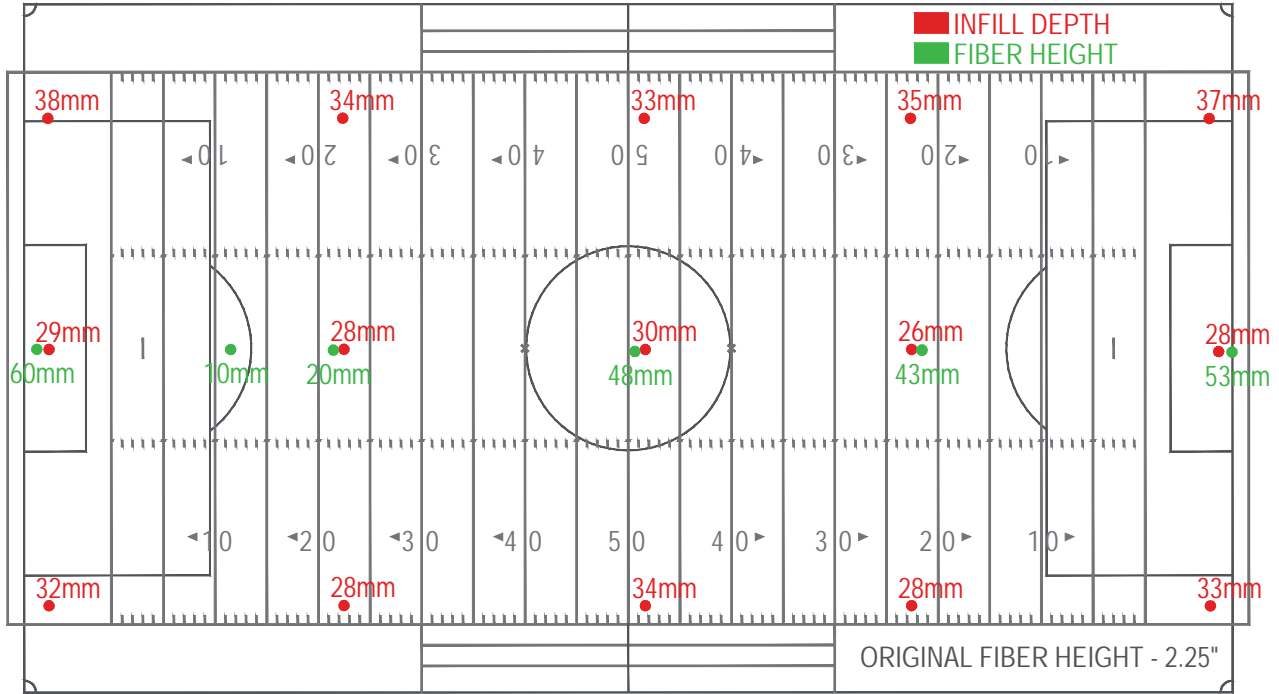
INFILL DEPTH MEASUREMENTS
 WEST LINN HIGH SCHOOL

The infill level of the field is slightly low based on typical 5/8" +/- exposed turf fiber above infill level. Also it mirrors the pattern of fiber wear and loss being low down the middle of the field and extremely low in excessive wear areas and worn white turf (see infill depth report attached).

RECOMMEND – It is possible to uniformly add infill to the field. Upon completion of Gmax testing discuss results to determine if addition infill is correct action. Also replace turf where fiber is insufficient to contain minimum infill amount.

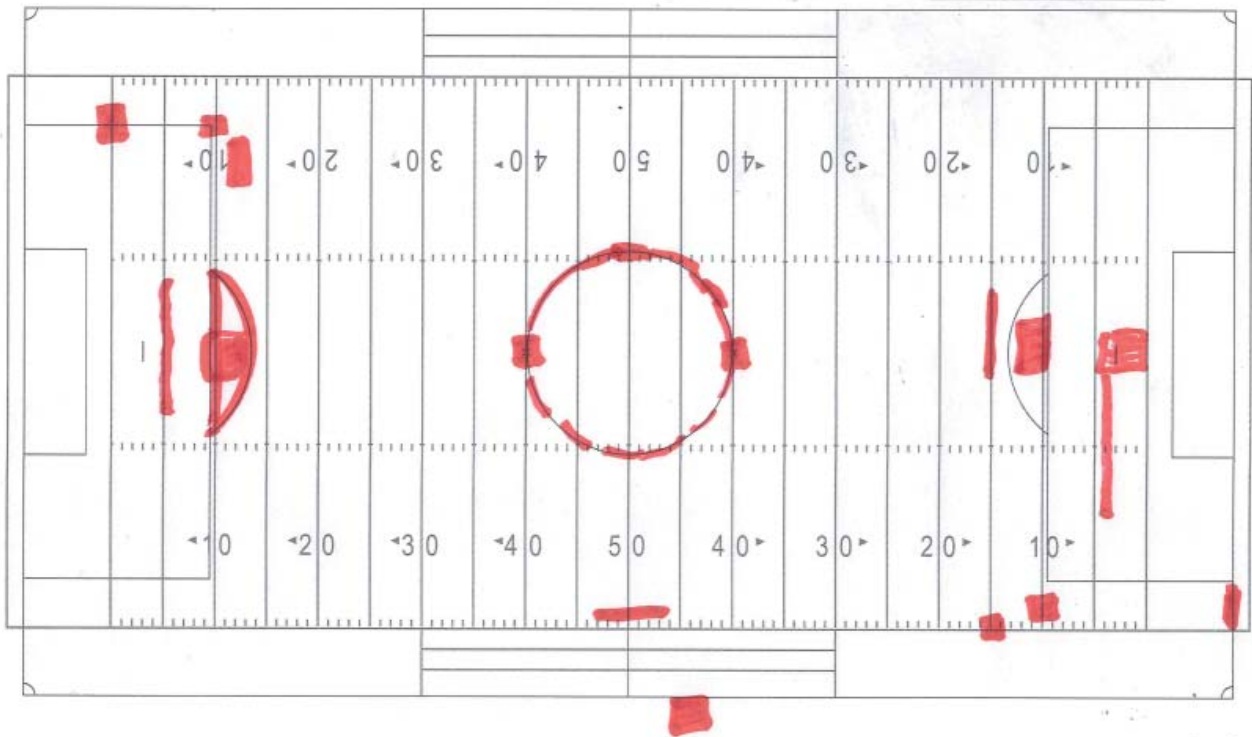
REPAIR AREAS
 WEST LINN HIGH SCHOOL

Turf is highly fibrillated (fibrillated refers to the "grass" slit-film-fiber that is designed to break down into many fine strands. On older fields the fibers continue to fibrillate and begin to fuzz). Shows typical pattern of greater wear down center of field... especially at areas of concentrated play. Lacrosse goal area, soccer penalty kick and goal mouth, and football kickoff x areas show greatest degradation. White lines fiber is shorter than adjacent green fiber due to accelerated UV degradation with highest worn areas at middle of field and high wear areas.

The field overall does not show signs of installation or product failure. Most hash marks and numbers are still adhered properly. Most seam failure is located within high wear areas at middle of field on both ends between the soccer arc and goal. Soccer center circle also shows high wear and loose turf sections.

RECOMMEND - Some areas need to be replaced with new turf due to advanced wear. Areas may have insufficient fiber height to hold infill at minimum level required for play. Lacrosse goal area and kicking x areas need replaced and possibly areas of highly degraded white turf areas to meet industry standard for Gmax.

RECOMMEND – Schedule turf repair contractor to identify and repair failed seams and replace turf at lacrosse goal and football x's. Replace additional areas deemed deficient upon Gmax test results.

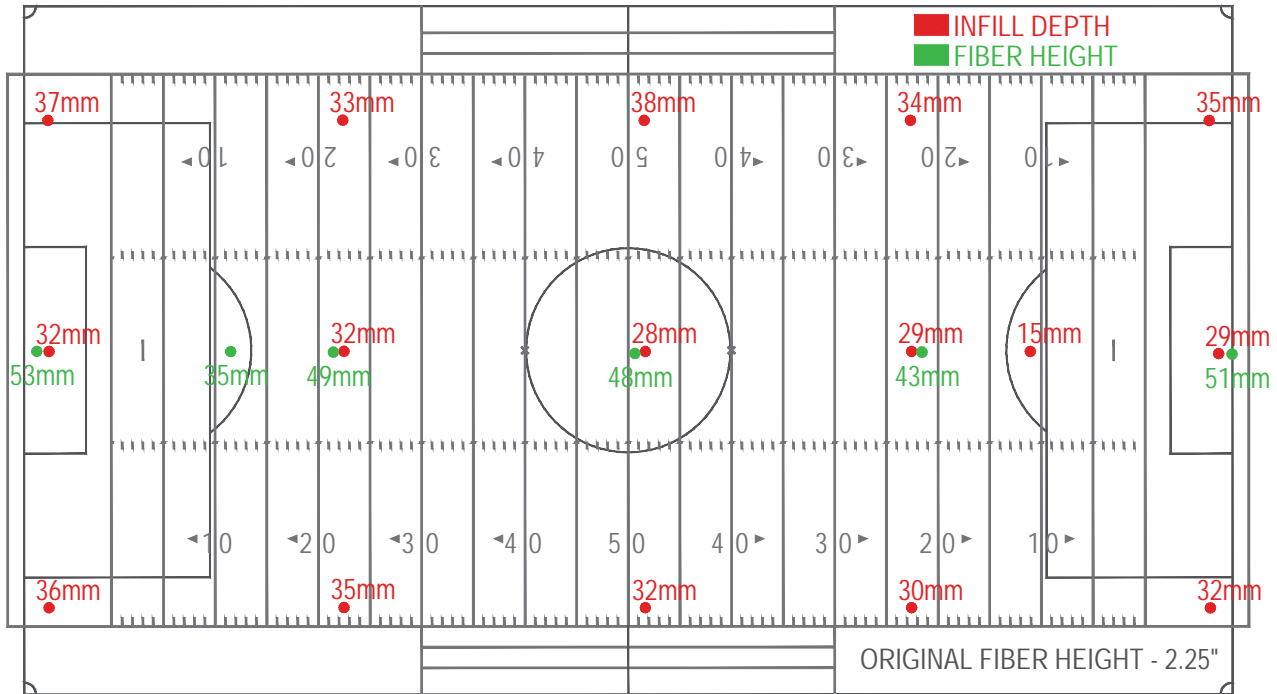
INFILL DEPTH MEASUREMENTS
 WILSONVILLE HIGH SCHOOL

The infill level of the field is just on the edge of being low based on typical 5/8" +/- exposed turf fiber above infill level. Level mirrors the pattern of fiber wear and loss being low down the middle of the field and extremely low in excessive wear areas and worn white turf (see infill depth report attached).

RECOMMEND – Upon completion of Gmax testing discuss results to determine if any action is required.

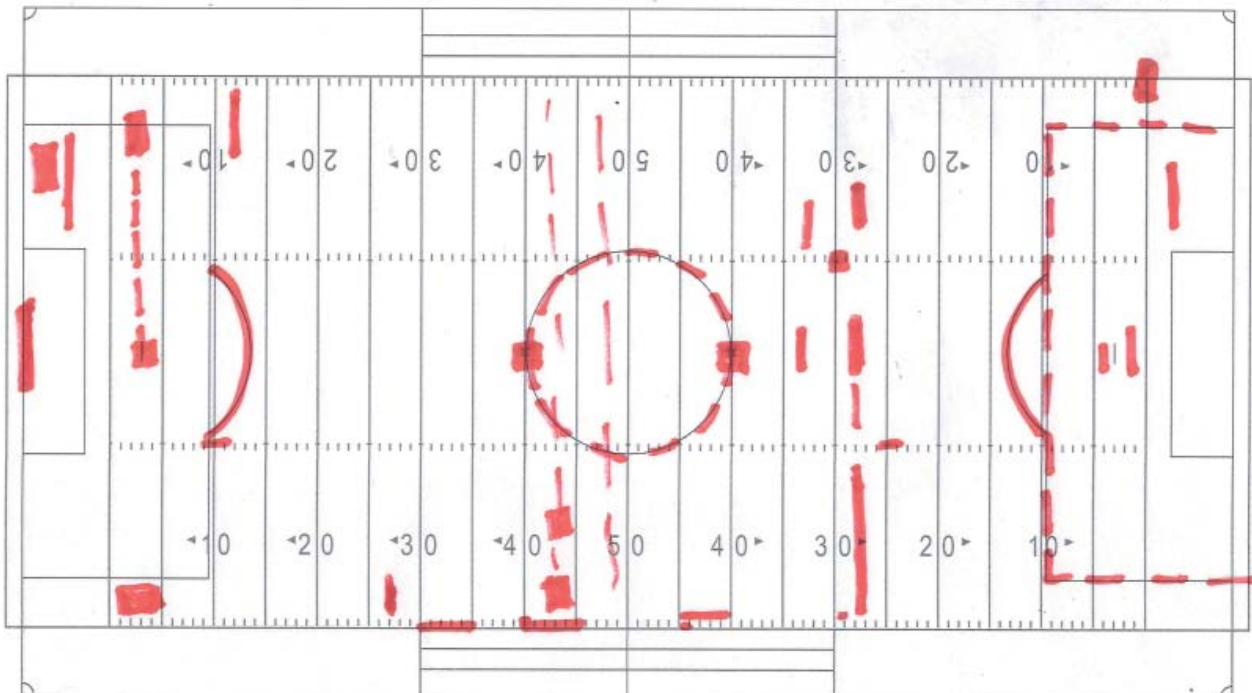
REPAIR AREAS
 WILSONVILLE HIGH SCHOOL

The sub base does not exhibit signs of serious differential settling or sinking. Small low area within field at 33 yd line. Also multiple lows and highs adjacent to seams that appear to have been caused during seam repair operations.

The field has had continual issues with seam failure. Moderate seam repair needed. Most hash marks and numbers are still adhered properly. Soccer box that was replaced needs repair and reinstall of infill to more closely match adjacent green turf height.

RECOMMEND – Contractor to review areas with owner during turf repair and correct.

RECOMMEND – Schedule turf repair contractor to identify and repair failed seams and correct turf at soccer boxes.

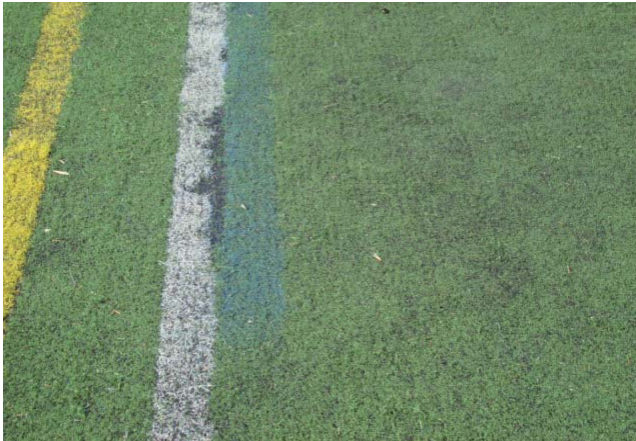
Drop area #11

Extra #11 - This is the "original" turf area at the boys lax goal crease area (the same as the replaced area on the other end). The Gmax here was 330. A "patch" here is recommended.

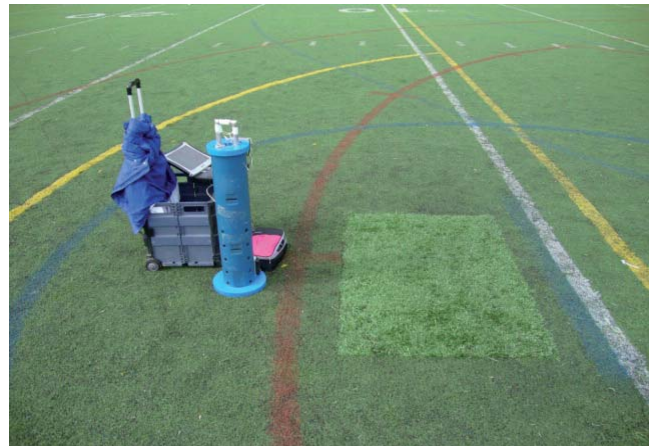
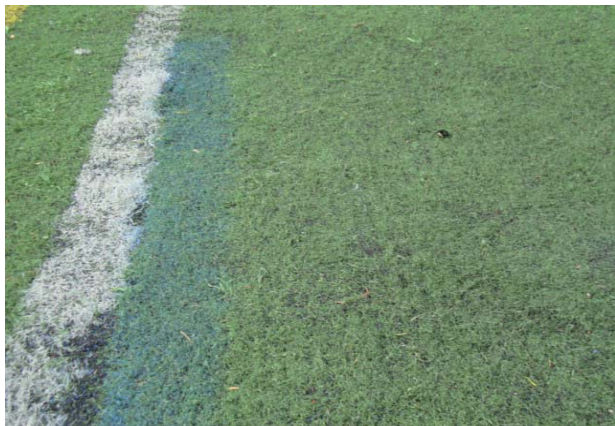
Drop area #12

Extra #12 - The new turf area on the north end is not a true drop location. The Gmax here was 183 and it had less than an inch of infill.

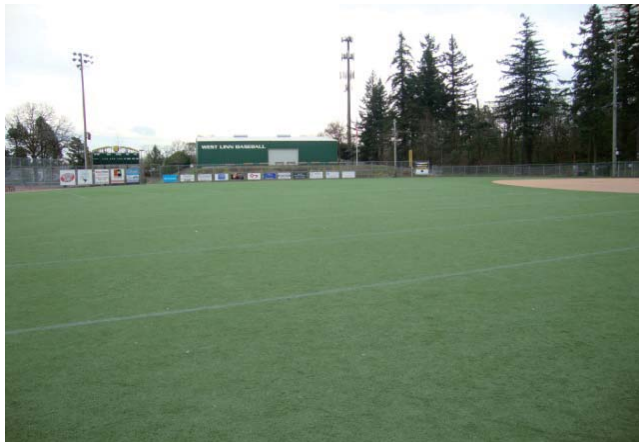
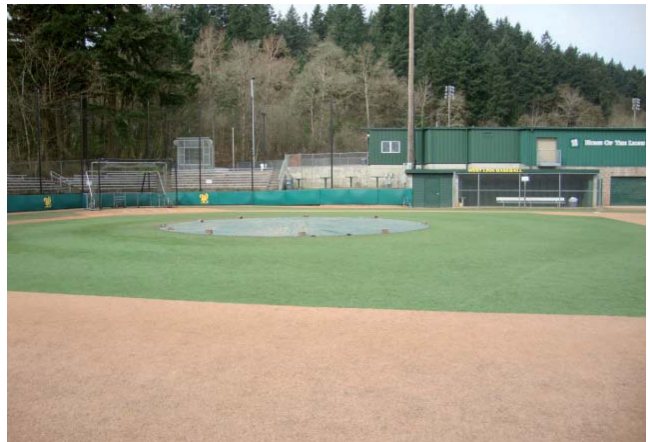
The Gmax exceeded the suggested maximum of 200 in at least one location.

Field Average Gmax	149.8
Field Max Gmax	212.6
Average Infill Depth"	1 7/16"

It is suggested that remedial work be done to improve the resilience of the field in the identified location.

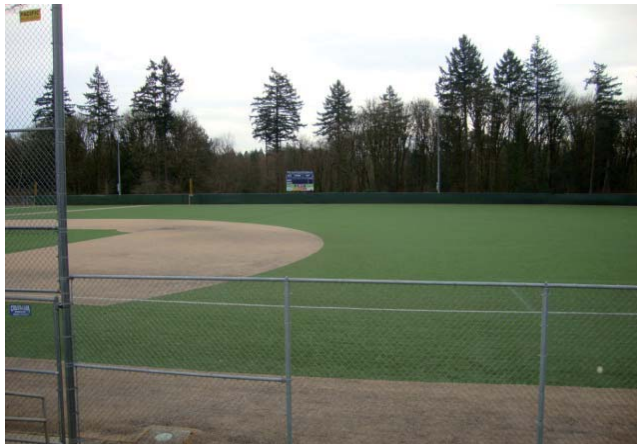
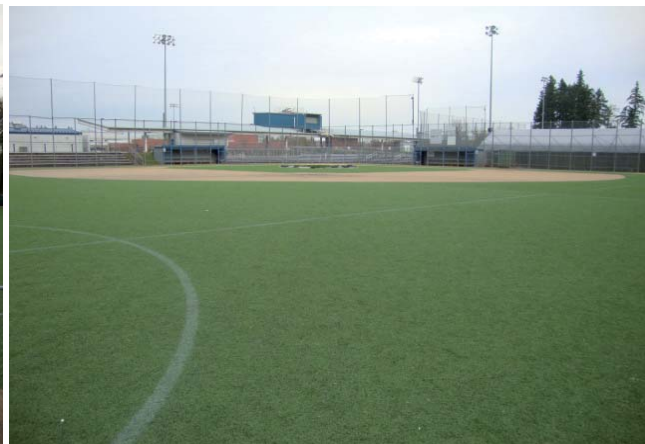
The Gmax exceeded the suggested maximum of 200 in at least one location (1 yard off of the first base).

Field Average Gmax	187.2
Field Max Gmax	248.12
Average Infill Depth "	1 1/4"

It is suggested that remedial work be done to improve the resilience of the fields.

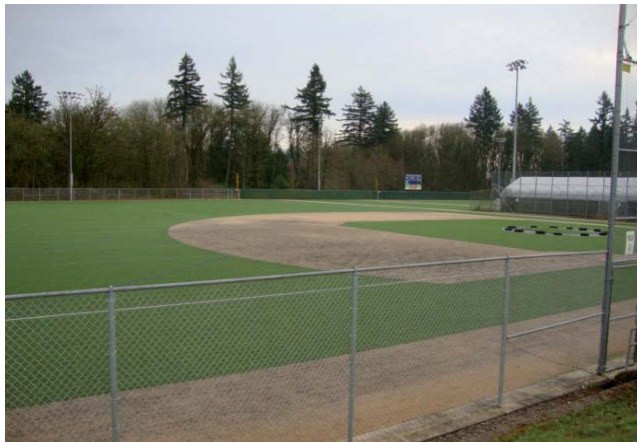
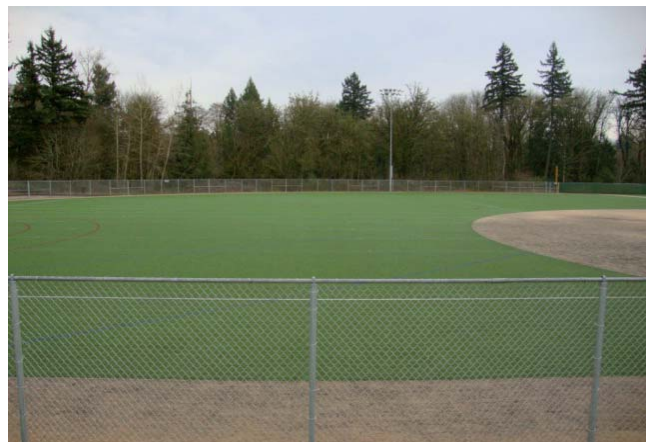
The Gmax exceeded the suggested maximum of 200 in each of the base test points. The infill didn't show to be low but it is mostly sand/dirt in those areas, no rubber left.

Field Average Gmax	167.2
Field Max Gmax	205.1
Average Infill Depth "	1 5/16"

It is suggested that remedial work be done to improve the resilience of the fields.
