ASBESTOS MANAGEMENT PLAN

**West Linn High School-Bolton Campus
5933 Holmes Street
West Linn, OR 97068**

WEST LINN-WILSONVILLE SCHOOL DISTRICT

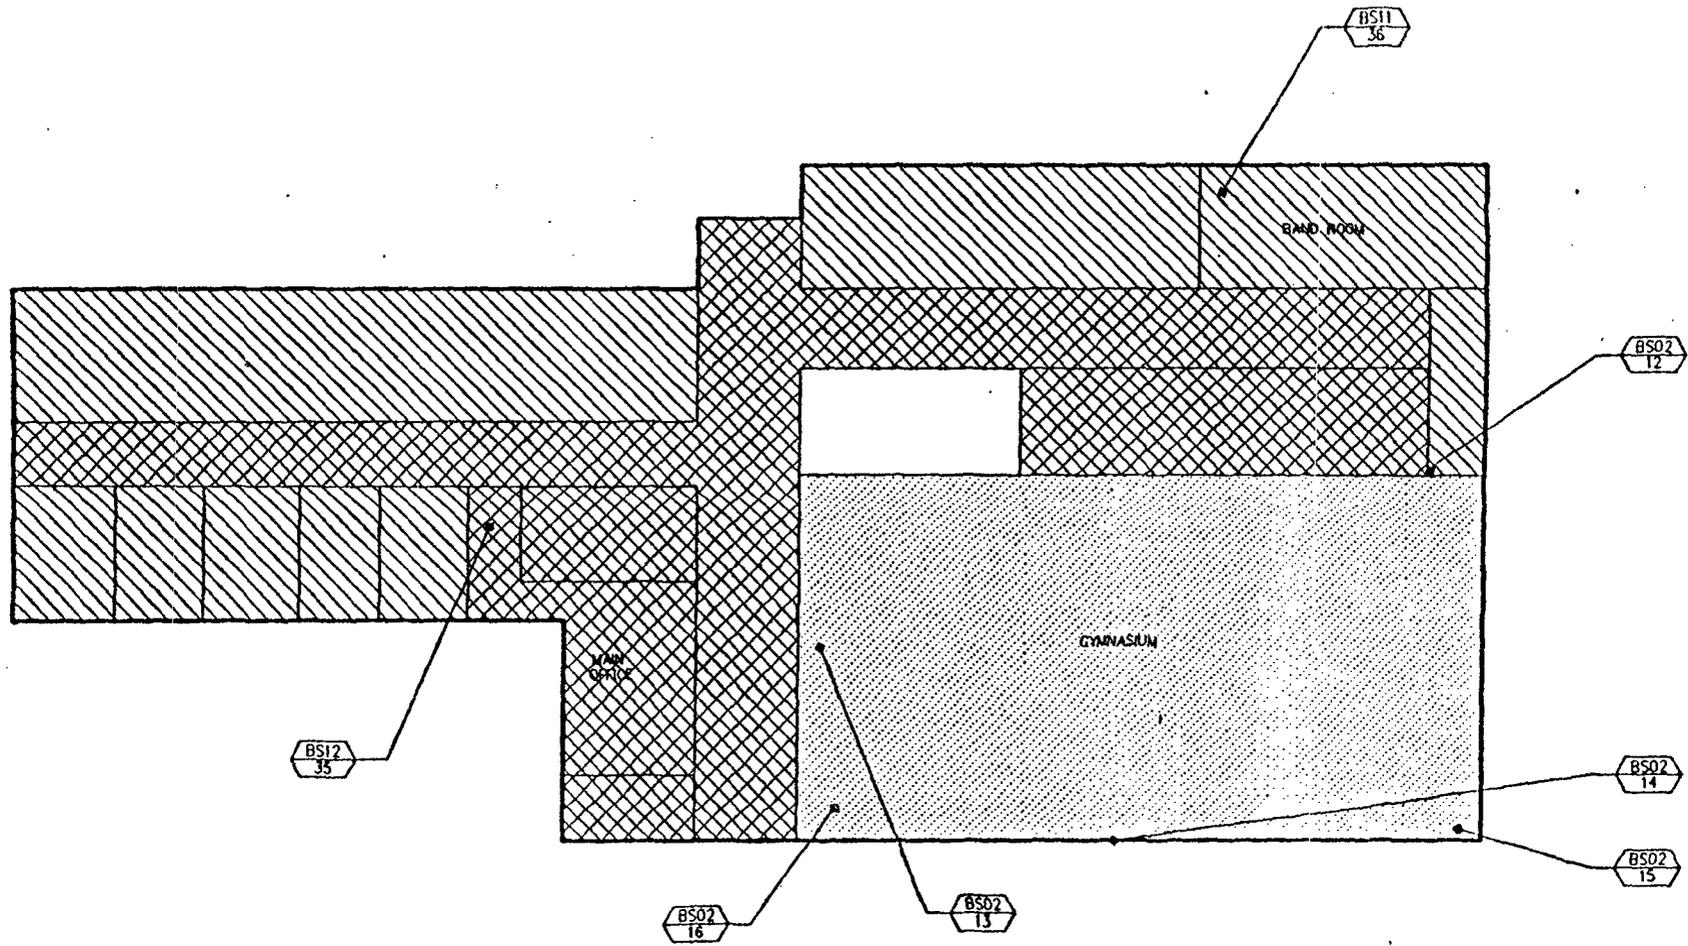
BSCODE QUANTITY LOCATION DAMAGE AREA	HALL-TIMBELL ENVIRONMENTAL SERVICES 4840 WEST FIFTEENTH STREET LAWRENCE, KANSAS 66044 DATE 10/03/08 0020010	AHERA COMPLIANCE PROGRAM 37-0050-002-001 WEST LINN SCHOOL DISTRICT BOLTON MIDDLE SCHOOL UPPER BUILDING MAIN FLOOR
	RESPONSE CODE

ALL FLOOR TILE CONTAINS ASBESTOS

— ASBESTOS CONTAINING THERMAL SYSTEM INSULATION

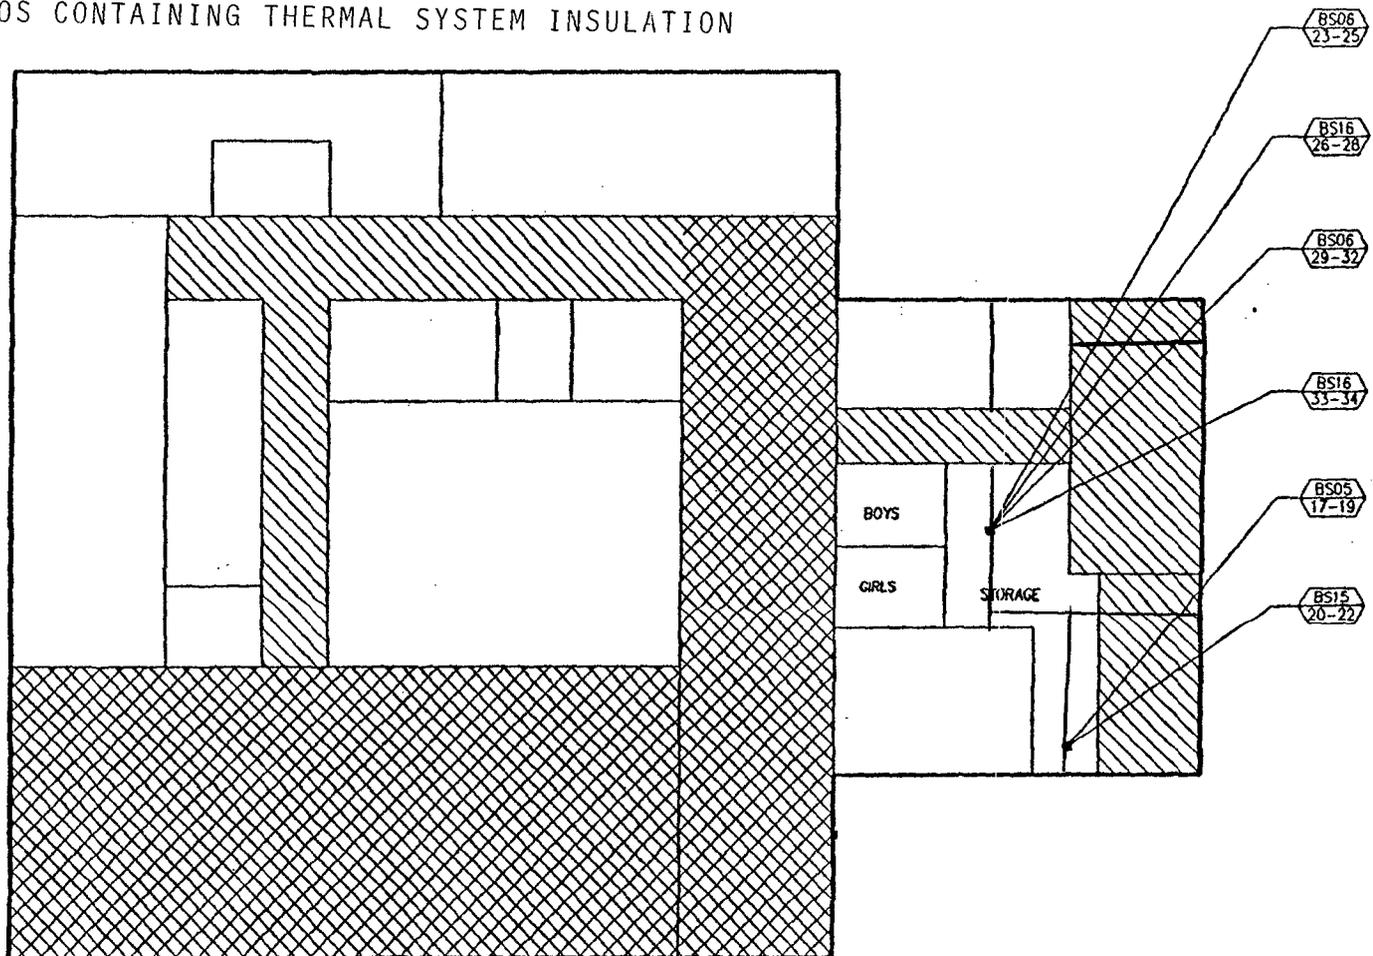
RESPONSE CODE	HALL-YEMMELL ENVIRONMENTAL SERVICES 4840 WEST FIFTEENTH STREET LAWRENCE, KANSAS 66044 DATE 10/03/88	AHERA COMPLIANCE PROGRAM 37-0050-002-001 WEST LINN SCHOOL DISTRICT BOLTON MIDDLE SCHOOL UPPER BUILDING LOWER LEVEL

ALL FLOOR TILE CONTAINS ASBESTOS

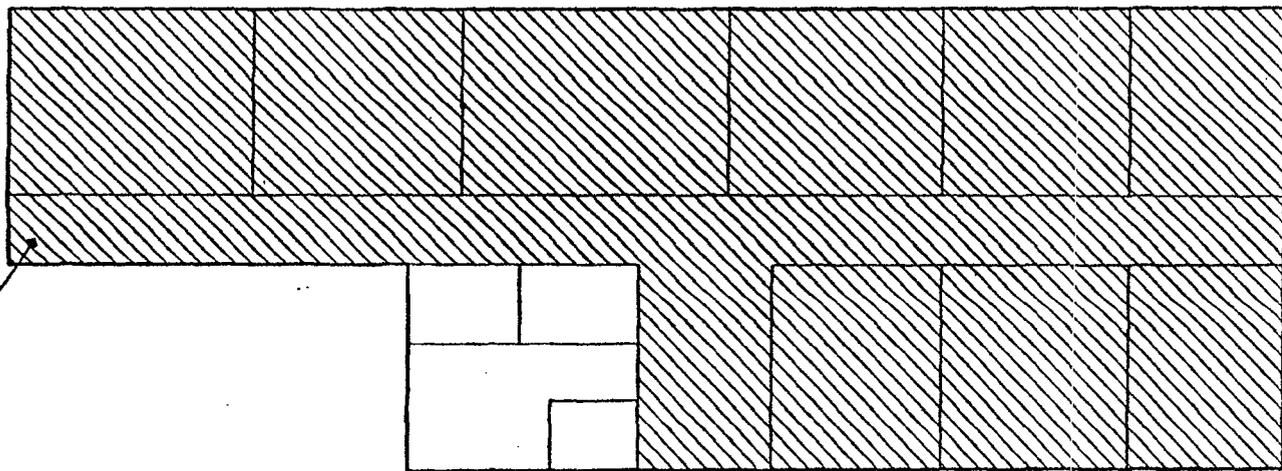
ALL FLOOR TILE CONTAINS ASBESTOS
