SYNTHETIC TURF FOOTBALL/SOCCER FIELDS EVALUATION REPORT

West Linn High School & Wilsonville High School

Submitted to West Linn - Wilsonville School District
by Dull Olson Weekes - IBI Group Architects, Inc.

March 19, 2013

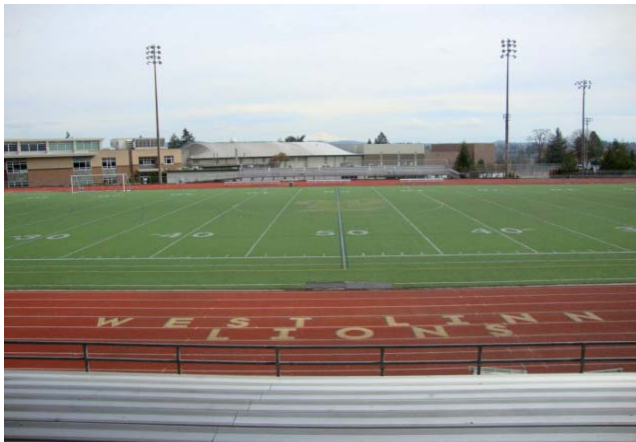
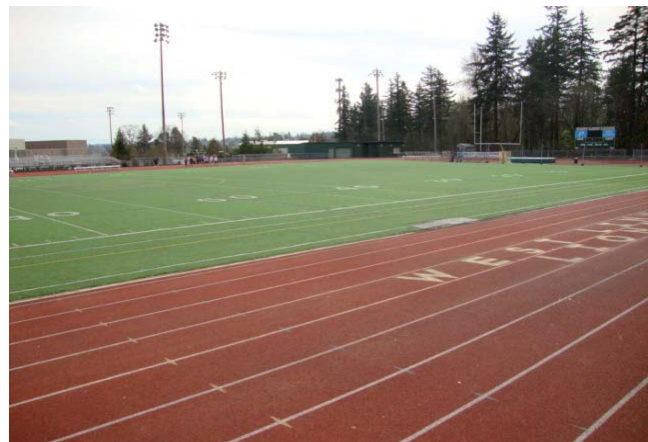
Summary of Results

Field Average Gmax	150.8
Field Max Gmax	165.6
Average Infill Depth "	1 1/4"

Test results reported herein reflect the conditions of the tested field at the time of testing and at the temperatures reported. Under the stated test conditions, all points met the requirement of < 200 Gmax when tested in accordance with ASTM F1936.

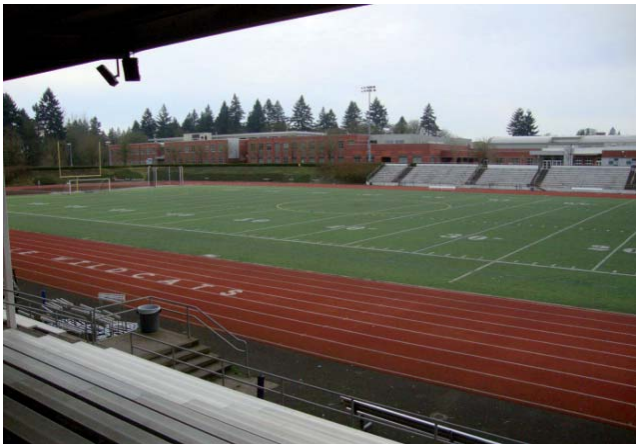
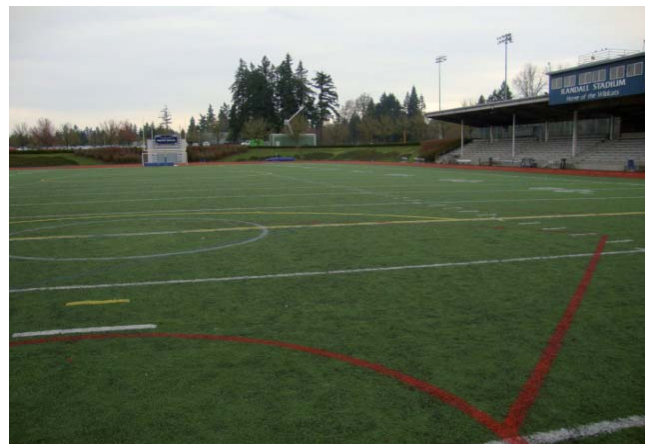
Summary of Results

Field Average Gmax	144.2
Field Max Gmax	160.3
Average Infill Depth "	1 7/16"

Test results reported herein reflect the conditions of the tested field at the time of testing and at the temperatures reported. Under the stated test conditions, all points met the requirement of < 200 Gmax when tested in accordance with ASTM F1936.
